2005 BANK EROSION MONITORING REPORT

SAN ACACIA REACH OF THE RIO GRANDE, NM

Final Report

**Department of the Interior
Bureau of Reclamation
Albuquerque Area Office**

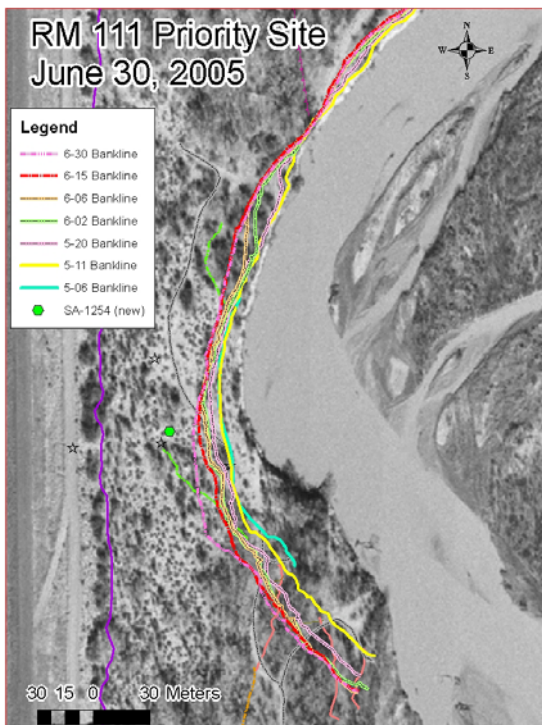
Movement of the bankline at the San Acacia RM 111 River Maintenance Priority Site was ongoing throughout the 2005 spring runoff (Figure 7). A bankline survey on October 4, 2005 showed that no significant bankline erosion occurred after the June 30th survey (Figure 5). This bend generally migrated 60 meters at the bend apex in the downstream direction, while the downstream extent migrated about 110 meters downstream. The area of the bend increased by 25% in 2005 (Table 1). The bank material present at this site is a combination of spoils and historical Rio Grande floodplain and riverine sediments composed of sand and silt. The bank is 8-10 feet (Figure 6) and varies between a vertical exposure and a slight lay-back.

Figure 7: Bankline locations for the migrating bend at RM 111 from early May through the end of June 2005.

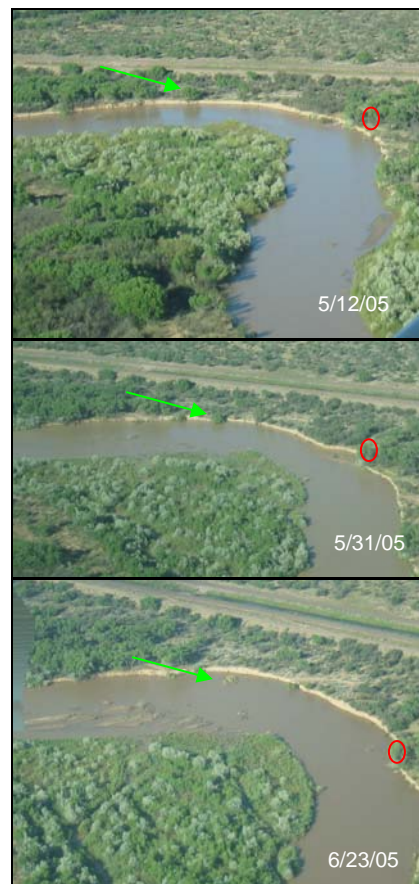
downstream from a relatively stable bank location (red circle on Figure 8). The stable bank location is anchored by a line of mature cottonwood trees that grew-up around an old fashion sediment retention line (similar to jetty jacks). As this small bend scoured out, the dominate direction of migration for the whole bend changed from predominately downstream to an almost perpendicular direction (west). During this phase, the bend apex shifted its location upstream.

Figure 8. Bend migration at RM 111. Green arrow points at a mature cottonwood; the red circle is a relatively stable bank location with mature cottonwood trees.

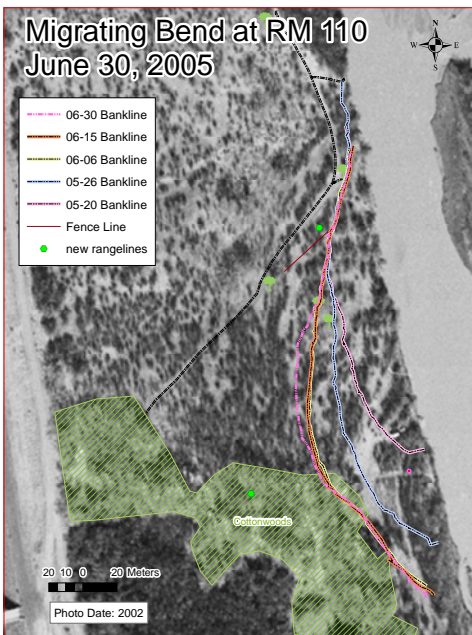
As stated earlier in this report, this bend initially formed in early May 2005, with the first detailed bankline data collected on May 20th, when it was determined that this bankline was rapidly retreating. The bankline location was mapped several times during runoff, and then two times after runoff ended. The initiation of this erosion is concurrent with the downstream migration of the RM110 East bend. The bank material present at this site is historical Rio Grande floodplain and riverine sediments composed of sand and silt. The bank is 8-10 feet higher than the current ordinary high flow (Figure 6) and forms a vertical bank.

Figure 9: Bankline locations for the migrating bend at RM 110 from just after bank erosion began in late May through the end of June 2005.

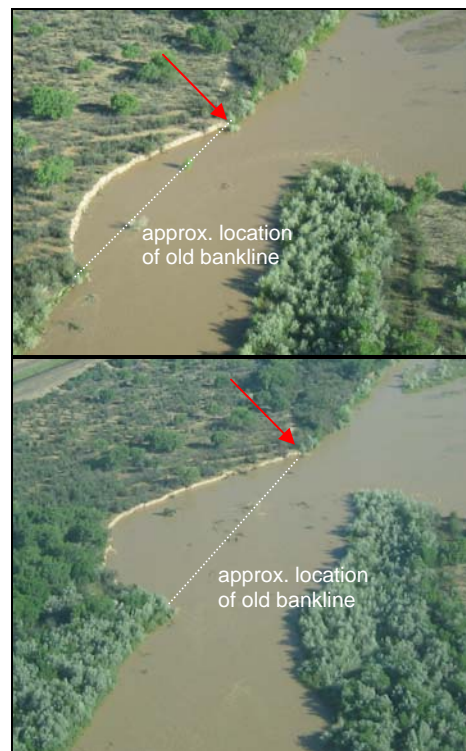
The initial bend formed as a large scallop eroded into the bankline (Figure 10) in early May 2005. During this phase, the erosion was measurable in feet of bankline retreat per day. The vegetation on the terrace eroding at this time was composed of small patches of dense and sparse saltcedar; the saltcedar patches do not appear to hinder

bend migration. The river continued to erode these sediments and vegetation through the end of May. In early June, the apex of the bend migrated into a stand of mature, relatively dense cottonwood trees; in response, the curvature of the bend tightened (Figure 10), and overall migration slowed. Since that time, the downstream migration of the bend appears stalled. However, bank sediments have continued to erode upstream of the cottonwood stand (Figure 9); as a result, the apex of the bend shifted upstream.

Figure 10: Aerial photos of RM 110 in early May 2005 (top photo) and early June 2005 (bottom photo). Note the location of the upstream end of the bend is stable (red arrow).

The current bankline at the bend apex is approximately 65 meters closer to the levee than it was prior to runoff. The length of the bankline increased as the bend developed and is currently about 50 meters longer than before the bend formed (Figure 10). The area of the current bend is approximately 12,400 m².

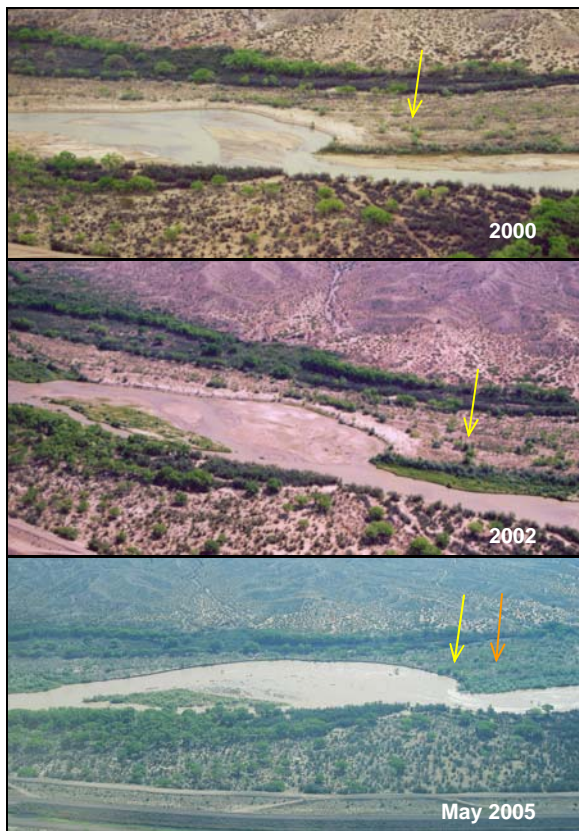
This bend initially formed about 1996 and began migrating in the late 1990s; bend migration stalled by 2000 and began vegetating (Figure 11). During the 2005 runoff event, this bend began migrating rapidly downstream; by the end of the runoff event, the apex of the bend had moved approximately 160 meters in the downstream direction (Figure 5). The length of the bankline increased from about 420 meters to 660 meters, while the area of the bend more than doubled (Table 2).

Figure 11: Aerial photos looking east towards the bend at RM 110 East (2000, 2002 and May 2005). The yellow arrow shows the location of a small stand of cottonwood trees in each of the photos. The orange arrow shows the approximate location of the bend apex/bankline in October 2005.

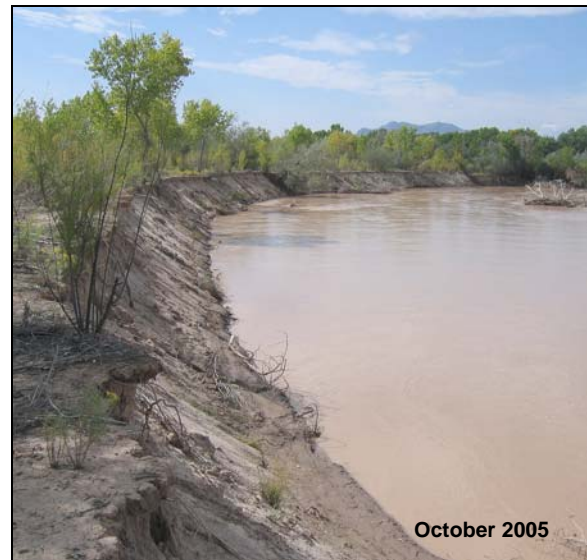
Unlike the bank material found at both the RM 111 bend and RM 110 West bend, this bank material was recently (within 20 years) deposited and abandoned riverine sediments. This loosely packed river sand (a.k.a., sugar sand, Figure 12) composes a 5 foot terrace (Figure 6). The vegetation on this terrace is sparse saltcedar, cottonwood, and the occasional Russian olive tree. Shrubs and cacti are also growing on the surface. The bank material appears to offer no resistance to the river erosion.

Figure 12: Looking upstream along the bankline at the RM 110 East bend. Note the lay back of the bankline, as the sugar sand lacks the ability to form vertical banks.

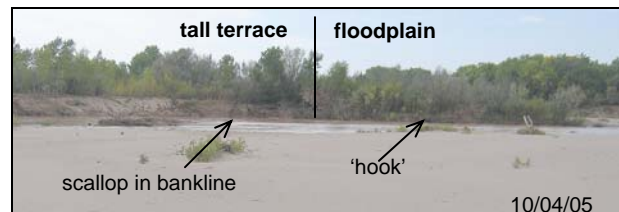
These densely vegetated surfaces are relatively resistant to river erosion and often create a 'hook' at the downstream end of migrating bends (Figure 5 and Figure 11). As the 'hook' impeded the downstream migration of the RM 110 East bend, a scallop formed in the bankline immediately upstream of the 'hook' which moved the apex upstream and the thalweg closer to the bankline. This sequence of events appeared to be necessary to erode the sediments and vegetation on the floodplain. The upstream scalloping of the bank material is almost like a partial flanking of the resisting surface; a true flanking of the 'hook' would leave a isolated patch of relatively undisturbed bank material (an island) in the channel, which has not occurred at these sites.

Figure 13: Looking downstream at the 'hook' in the RM 110 East bend: the bank height transitions from a tall bank to a short bank (floodplain).

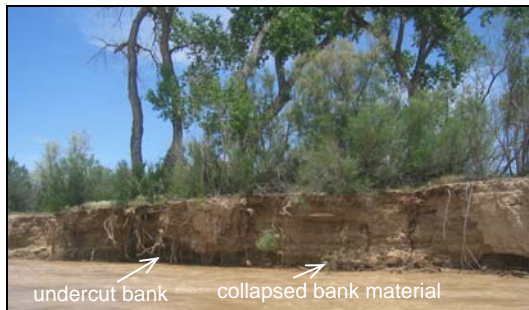
Bank erosion for tall terraces occurs directly at the base of the terrace and was quite visible throughout runoff. The erosion process has two steps: first step is erosion at the water surface level creating an undercut (Figure 14). Since this type of erosion is selective (e.g., only eroding the fine sediment), it easily scours around deeper root that have minimal mass structures, such as saltcedar tap roots (Figure 15).

The second step of bank erosion for high banks is bank failure or collapse which occurs catastrophically as the undercut bank material falls in to the river channel (Figure 14). The amount of undercutting depends

on the size of the root mass in the top layer of the bank (i.e., large cottonwood root mass creates a larger undercut bankline).

Figure 14: Undercut banks at RM 111, near San Acacia, NM on the Rio Grande, May 2005.

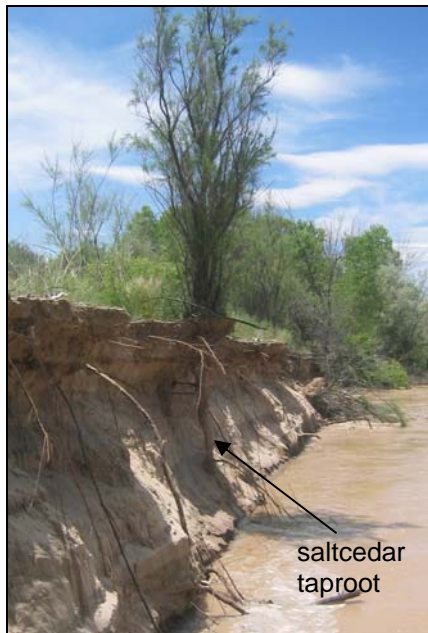
Vegetation on the tall banks consists primarily of saltcedar and mature cottonwood trees. The root masses from saltcedar do not appear to significantly hinder bank erosion, as the river easily erodes the bank sediment surrounding the saltcedar taproot (Figure 15). Conversely, the large, horizontal cottonwood root-masses provide enough bank support to create large undercut banks (Figure 16).

Figure 15: Bank erosion at RM 111, near San Acacia, NM on the Rio Grande, May 2005. Mature saltcedar poised on the eroding bankline, ready to fall into the Rio Grande.

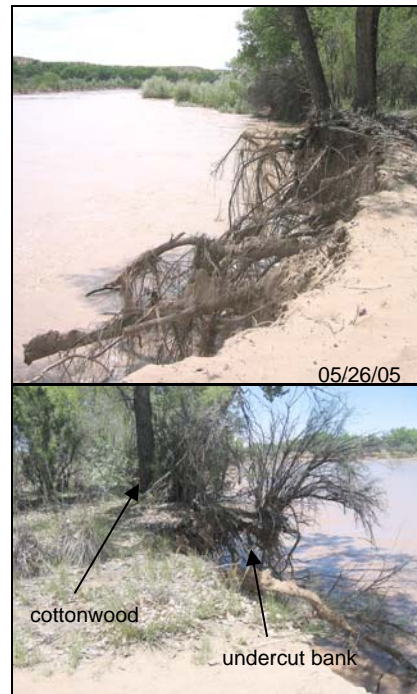
Figure 16: Large undercut bank at RM 111 on May 20, 2005.

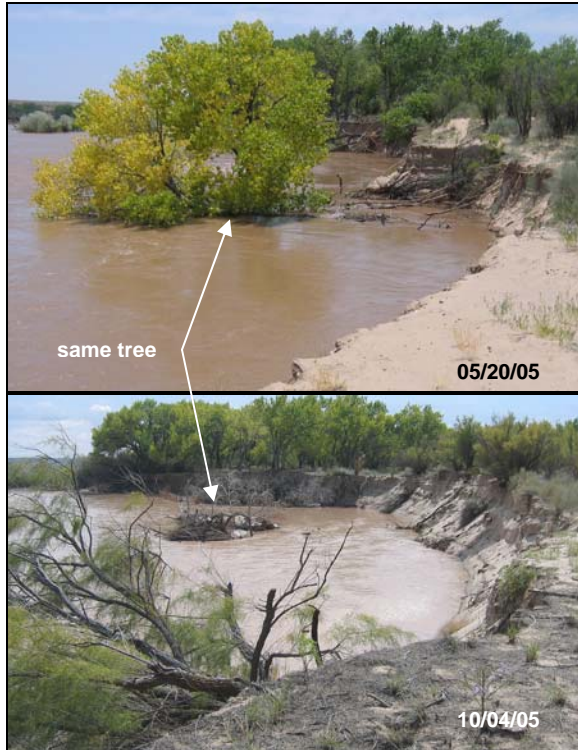
Woody debris accumulation during a bank migration event can both hinder and aid bankline erosion. The accumulation of in-channel debris along an eroding bankline can hinder bankline retreat (Figure 17) as the large trees re-direct the thalweg away from the bankline. In fact, at the RM 111 bend, the large cottonwood in the May 20th photo (Figure 17) took several weeks to fall into the river, and during that time, it noticeably hindered bend migration. However, after it fell, the river rapidly eroded the bankline next to the tree, with the tree appearing to aid the erosion by directing the thalweg into the bankline (Figure 17).

Figure 17: Bank erosion at RM 111, near San Acacia, NM on the Rio Grande. Note the extensive bankline retreat since this cottonwood fell into the Rio Grande.

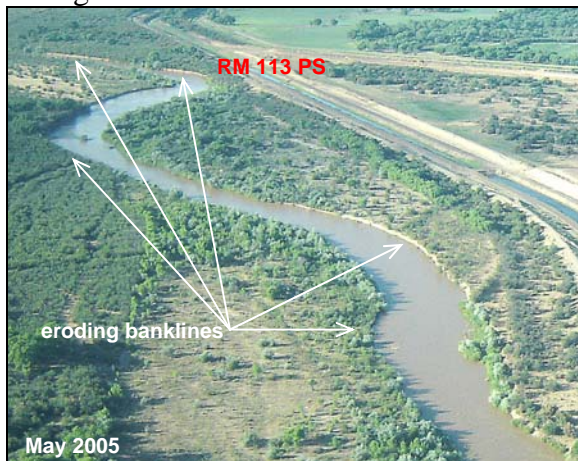
Large sections of bankline are eroding upstream of Arroyo Alamillo (Figure 1), however all of this erosion appears to be simply ‘widening’ of the river channel. The eroding banklines tend to have a relatively long length, while the bend has a low curvature. The most important characteristic of these types of bends is the lack of active point bar growth opposite the bank erosion (Figure 18). Without ongoing deposition on the inside of the bend, the full cross section of the channel stays relatively deep and active at even low flows. Also these banklines did not retreat significantly during the runoff event.

Figure 18: Aerial photograph of alternating eroding banklines along the Rio Grande between RM 114 (lower right) and RM 113 (upper left) in the San Acacia area.

Obviously, the migrating bends can easily move the river channel into and beyond the levee system that is present to the west; perhaps less obvious is that even the slower ‘widening’ bends are moving the location of the river’s edge and should also be routinely monitored, albeit with less rigor than the actively migrating bends. Further investigations are necessary to: 1- assess measurable characteristics that define each type of river bend, 2-create a model that defines the formation of the two types of bends, and 3-prepare a model that could predict whether the ‘widening’ bends will transform into migrating bends.

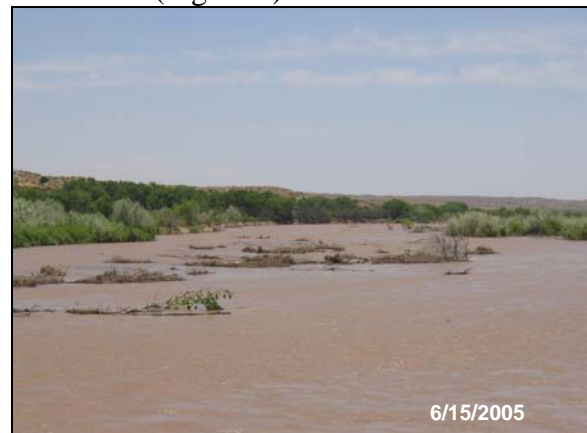
The three bends between RM 111 and RM 110 which were described earlier, are classic examples of migrating bends. Although these bends became quite large during 2005, they have a curvature that is relatively tight compared to the ‘widening’ bends found upstream of Arroyo Alamillo. Most distinctively, large point bars (Figure 19) were observed growing as the bankline retreated, in fact, these point bars emerged just after the runoff peak and remained emerged as water level decreased. The retreat of the bankline was not only significant, but large enough to warrant periodic mapping to determine rates of movement (Figure 5).

Figure 19: Point bar growth on east bank, opposite the eroding bankline at the RM 111 River Maintenance Priority Site.
